Bomanite Toppings Systems

PROJECT PROFILE

UNCLE JULIO'S RESTAURANT

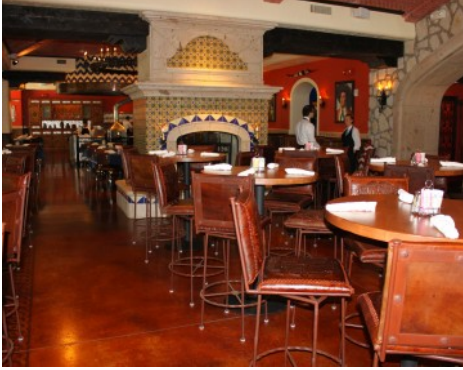
Uncle Julio's Restaurant - Austin Texas Bomanite
Chemical Stain

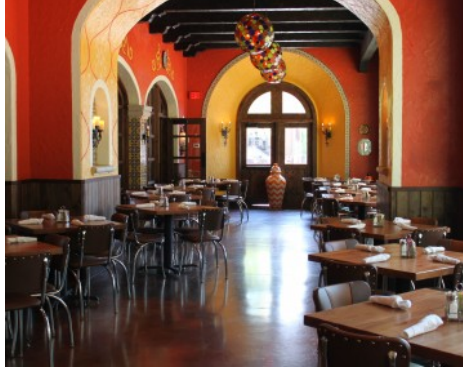
Uncle Julio's Restaurant - Austin Texas Bomanite
Chemical Stain

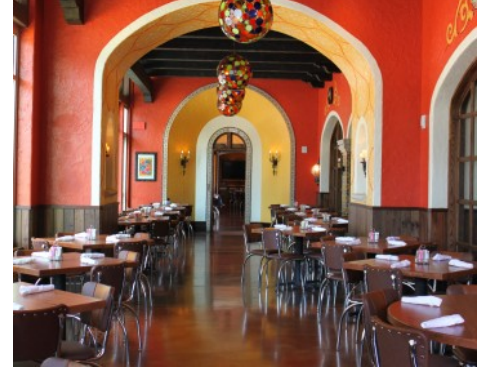
Uncle Julio's Restaurant - Austin Texas Bomanite
Chemical Stain

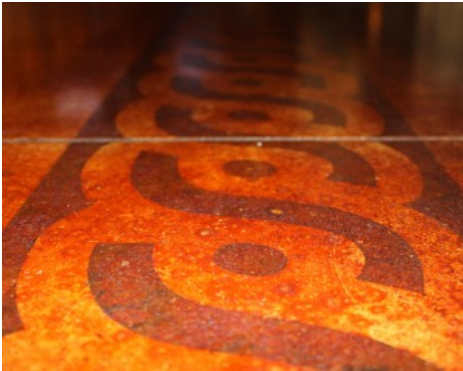
Uncle Julio's Restaurant - Austin Texas Bomanite
Chemical Stain and Braided Boarder Stencil

Texas Bomanite was brought in very early by the interior designer, GHA Architecture, and was able to fine-tune the exact desired look of the project by providing several samples of colors and stencil designs. In order to complete the antique and rustic look, Texas Bomanite used multiple colors of acid stain (specifically Bomanite Chemical Stain Auburn, Seal Brown and Ebony) and a custom antiquing and weathering process as well as stenciled a patterned braided border around the perimeter. The floor was sealed with an epoxy primer and two-part urethane sealer, Bomanite Florthane WB.

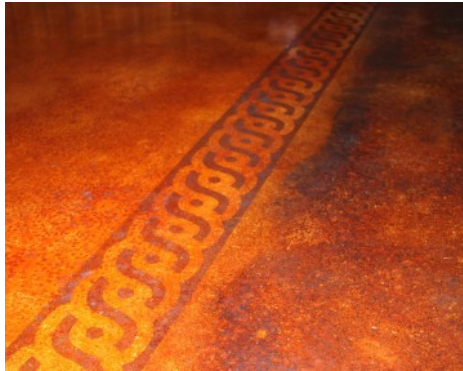
Uncle Julio's Restaurant - Austin Texas Bomanite
Chemical Stain and Braided Boarder Stencil
