PROJECT PROFILE

Project Name/Location: River Band Executive Center,
One Omega Drive, Stamford, CT 06907

Bomanite System: Grasscrete - Reusable Formers

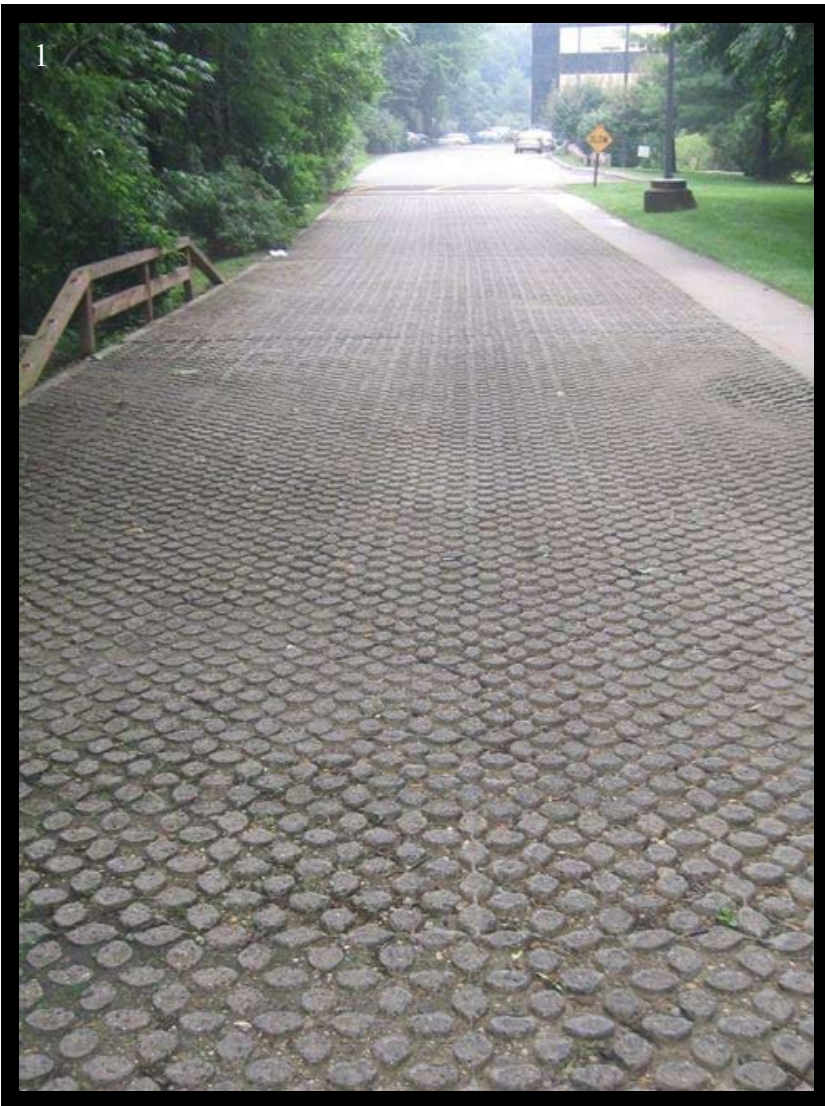
Photo 1: Grasscrete System installed across wetlands to provide access for security and emergency services.

Traffic Durability: The pictures featured were taken at the Stamford project July 19, 2006. The accessway was initially installed across wetlands to provide access for security and emergency services. This commercial park is split in two parcels with wetlands separating them. There is approximately 8 buildings on one side and 20 buildings on the other side. There are only two entranceways into these two areas and they cross over active railroad tracks. This was the reason to connect the two parks to allow two egresses for both parks. Because of the limited access to these areas, the Grasscrete accessway is used for more than security and emergency services. This connector is vital for all who work there to get from one building to the other without going over the tracks. More important than the high traffic of the employees who work there is the high traffic of delivery trucks and tractor trailers who cross the accessway daily to deliver their products.

For almost 20 years this accessway was not being used for the reason it was intended to be used. As you can see by the photos the Grasscrete has stood up to the high traffic. Note, in the photos that there is no grass growing in the top soil spaces of the Grasscrete- This only happens with very high traffic.

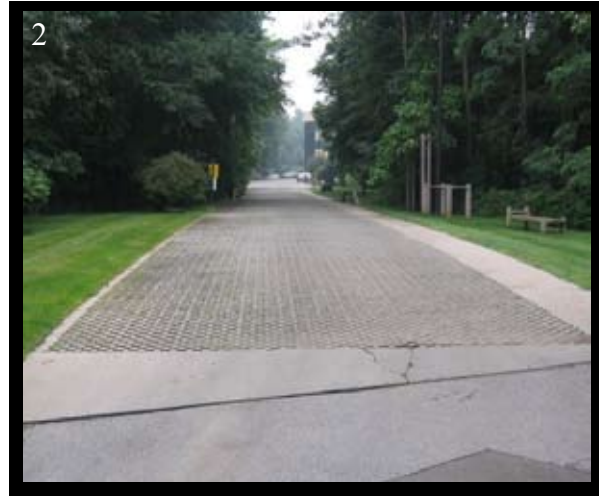
Photo 2: Upgraded roadway with Grasscrete System.

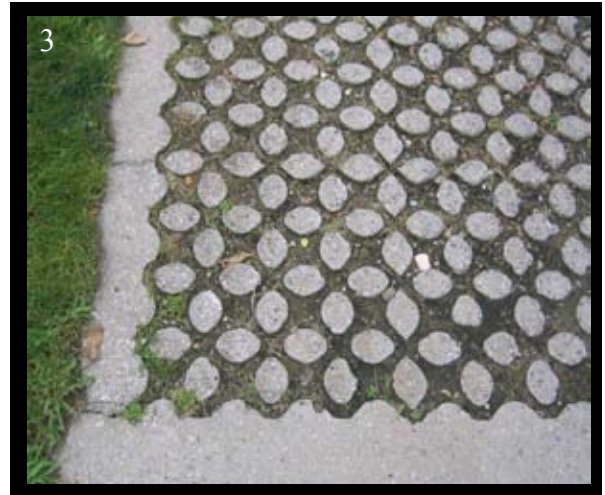
Photo 3: Close-Up of Grasscrete System installed.

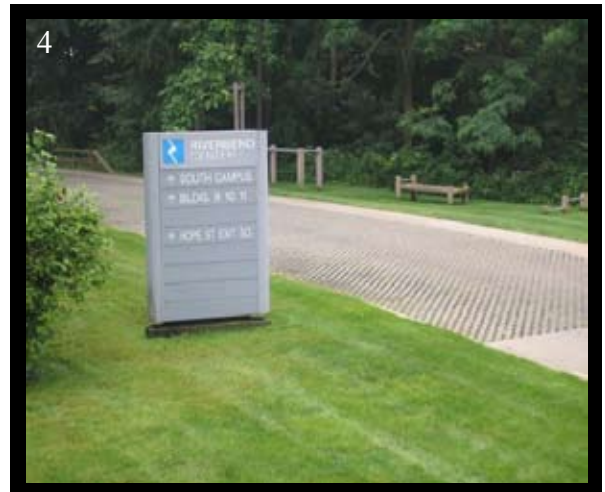
Photo 4: Upgraded roadway with Grasscrete System (2).
