Bomanite Toppings Systems

PROJECT PROFILE

UNCLE JULIO'S RESTAURANT

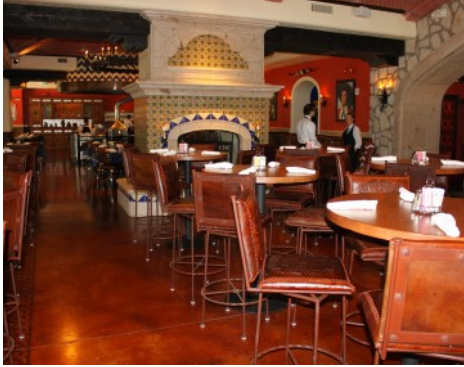
Uncle Julio's Restaurant - Austin Texas Bomanite Chemical Stain

Bomanite Chemical Stains produce a mottling of color tones that are directly affected by the substrate color and porosity. Variations and inconsistencies in color are expected and are usually the reason for using this coloring technique. Bomanite Chemical Stain will not chip, crack, fade or peel, making it a perfect fit for the interior restaurant floor.

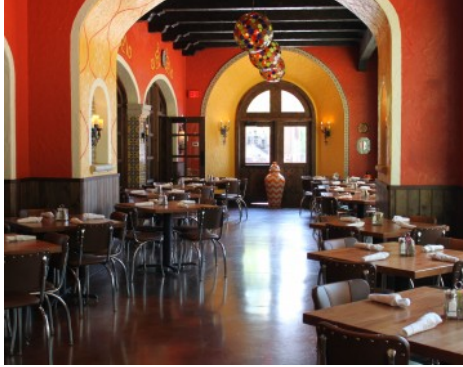
Uncle Julio's Restaurant - Austin Texas Bomanite Chemical Stain

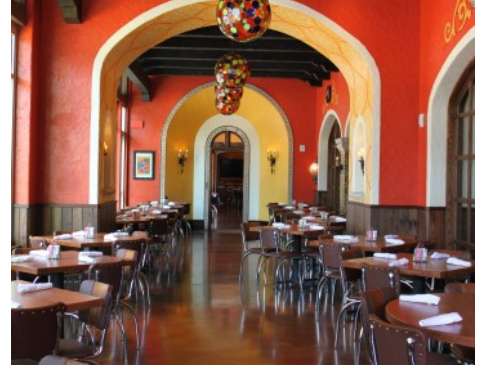
Uncle Julio's Restaurant - Austin Texas Bomanite Chemical Stain

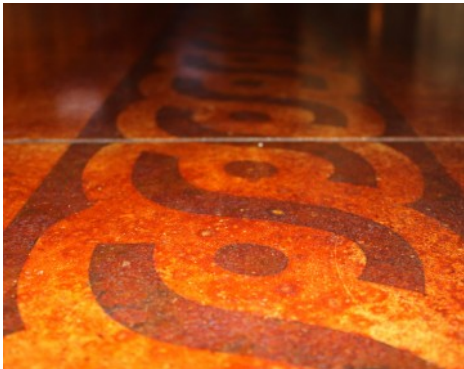
Uncle Julio's Restaurant - Austin Texas Bomanite Chemical Stain and Braided Boarder Stencil

Texas Bomanite was brought in very early by the interior designer, GHA Architecture, and was able to fine-tune the exact desired look of the project by providing several samples of colors and stencil designs. In order to complete the antique and rustic look, Texas Bomanite used multiple colors of acid stain (specifically Bomanite Chemical Stain Auburn, Seal Brown and Ebony) and a custom antiquing and weathering process as well as stenciled a patterned braided border around the perimeter. The floor was sealed with an epoxy primer and two-part urethane sealer, Bomanite Florthane WB.

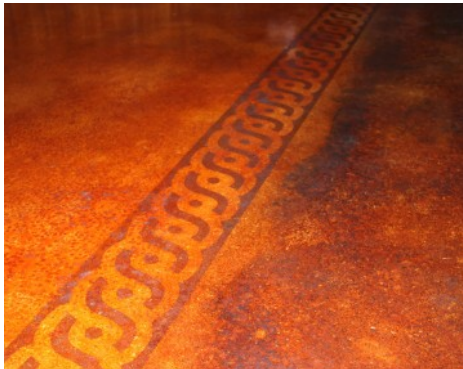
Uncle Julio's Restaurant - Austin Texas Bomanite Chemical Stain and Braided Boarder Stencil
