PROJECT PROFILE

Project Name: Cottonwood Creek
 Location: Englewood, Colorado
 Install Completed: Installed in 1988 - Photos taken August 2009
 Nature of Business: Service Road
 Approx. Square Feet: 1,200 sq. ft.
 Bomanite System: Grasscrete - GC2 - Reusable Formers
 Bomanite Licensed Contractor: Colorado Hardscapes
 8085 E. Harvard Avenue
 Denver, CO 80231
 Tel: 303-750-8200
 Fax: 303-750-8886
 Email: info@coloradohardscapes.com
 Website: www.coloradohardscapes.com

PROJECT PROFILE
Photo Gallery - Cottonwood Creek Service Road

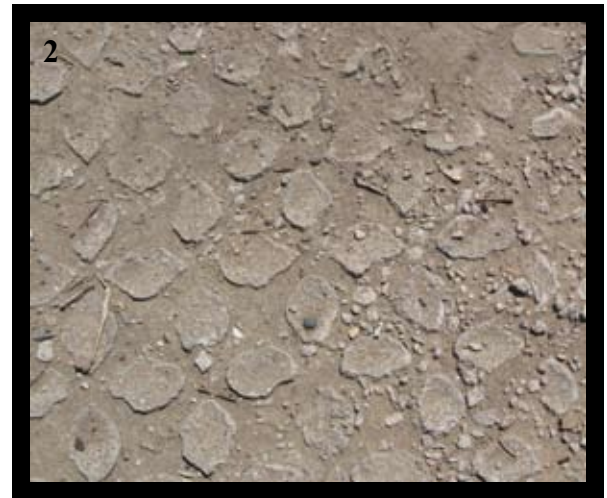
Photo 2: 20 year old grasscrete

The Cottonwood Creek Service Road, located in Englewood, Colorado was constructed with the Bomanite Grasscrete System - Reusable Formers. The access road is used for heavy dredging equipment to periodically clean silt deposits that collect next to the underpass and is predominately natural vegetation with a small section of gravel filled voids. The pattern from the dredging equipment's tracks are visible but are still largely covered with native plants. To most observers, they would not know that there is a concrete road under the plants that allows access in all weather conditions down the slope. There are no washouts from runoff that occurs from the street above the road nor any down the length of the road, even though in heavy rainfall this area would be exposed to aggressive erosion. The upper portion that is gravel filled has held up for 20 plus years even though areas of conventionally poured concrete have been removed and replaced over time. The conventional concrete stands out visually far more than the Grasscrete areas.

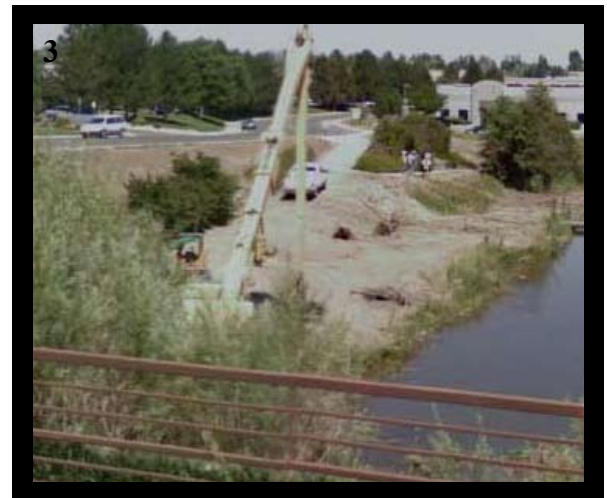
Photo 3: Dredging Equipment

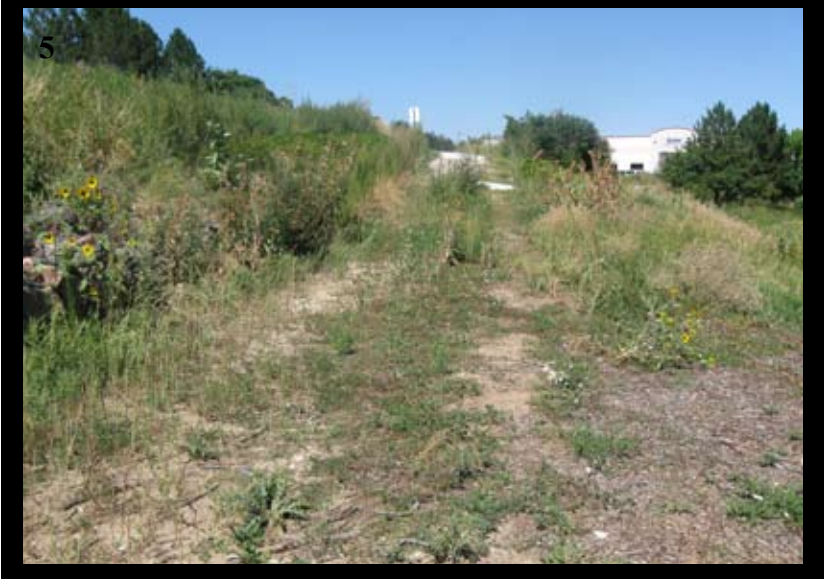
Photo 5: Dredging equipment track marks
