grasscrete

## CASE STUDY

<b>PROJECT:</b>	<b>Nostell Priory Stately Home Nostell, Wakefield, West Yorkshire</b>
<b>CLIENT:</b>	<b>The Right Honourable Lord St Oswald</b>
<b>FUNCTION:</b>	<b>Verge Parking</b>
<b>CONTRACTOR:</b>	<b>Chantry Contractors Limited</b>
<b>SYSTEM:</b>	<b>GRASSCRETE GC2 (150mm thick)</b>
<b>QUANTITY:</b>	<b>800 m<sup>2</sup></b>
<b>CONSTRUCTED:</b>	<b>1983</b>

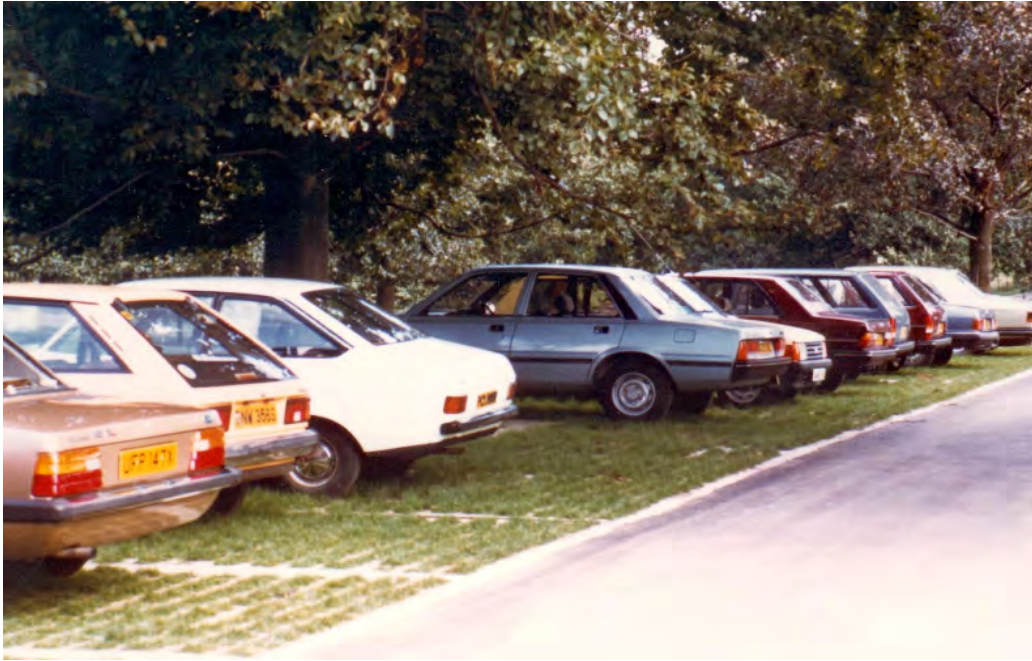
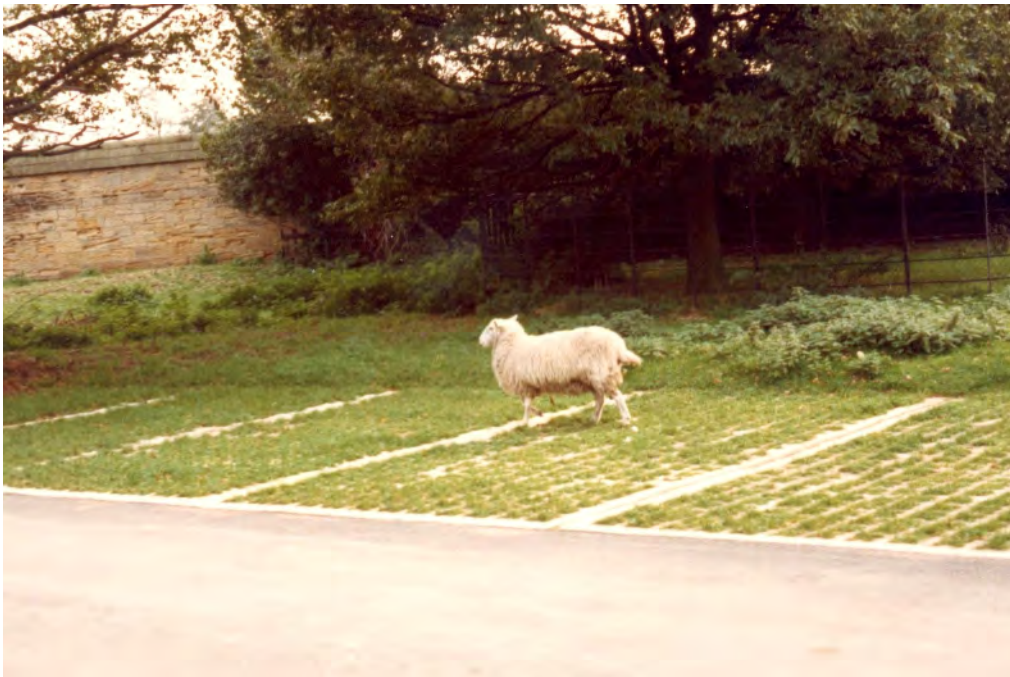
FROM INTENSIVE PARKING INCLUDING STEAM TRACTION ENGINES  
AND FUNCTION DAYS
